Investigation Report
Worker Fatally Injured While
Dismantling Tower Crane
April 27, 2016

Incident summary

A crew of workers and a third party mobile crane operator were dismantling a tower crane at an industrial construction project. When the mobile crane operator attempted to hoist the apex structure of the tower crane from its mounting lugs, the apex structure swung out of control and struck one of the workers, causing fatal crush injuries.

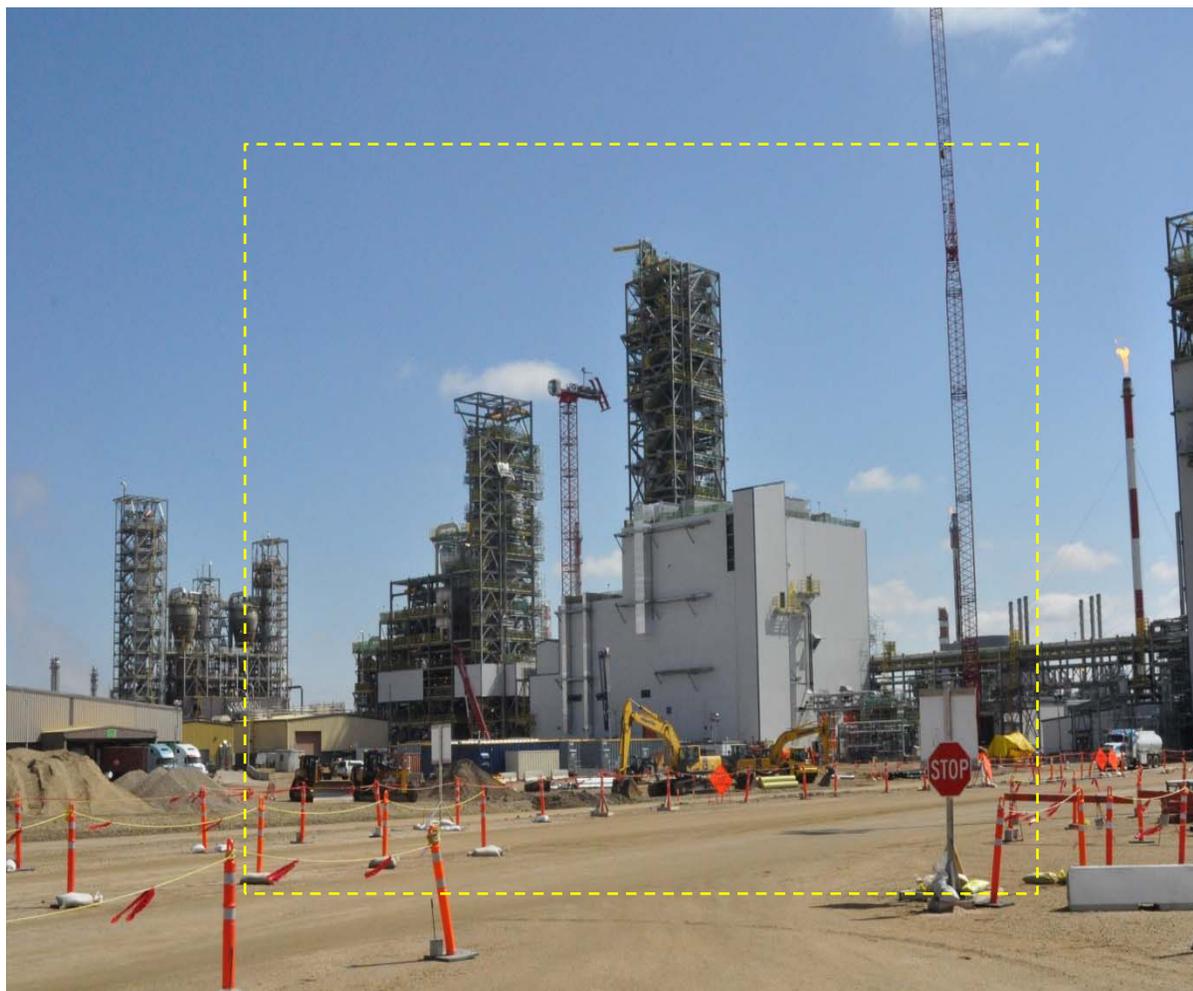
Figure 1. R3 Project with yellow hatched border showing the active construction area.

Under the terms and conditions of the R3 Project contract and Responsible Care Plan, NOVA maintained responsibility as prime contractor for the R3 Project (Figure 1).

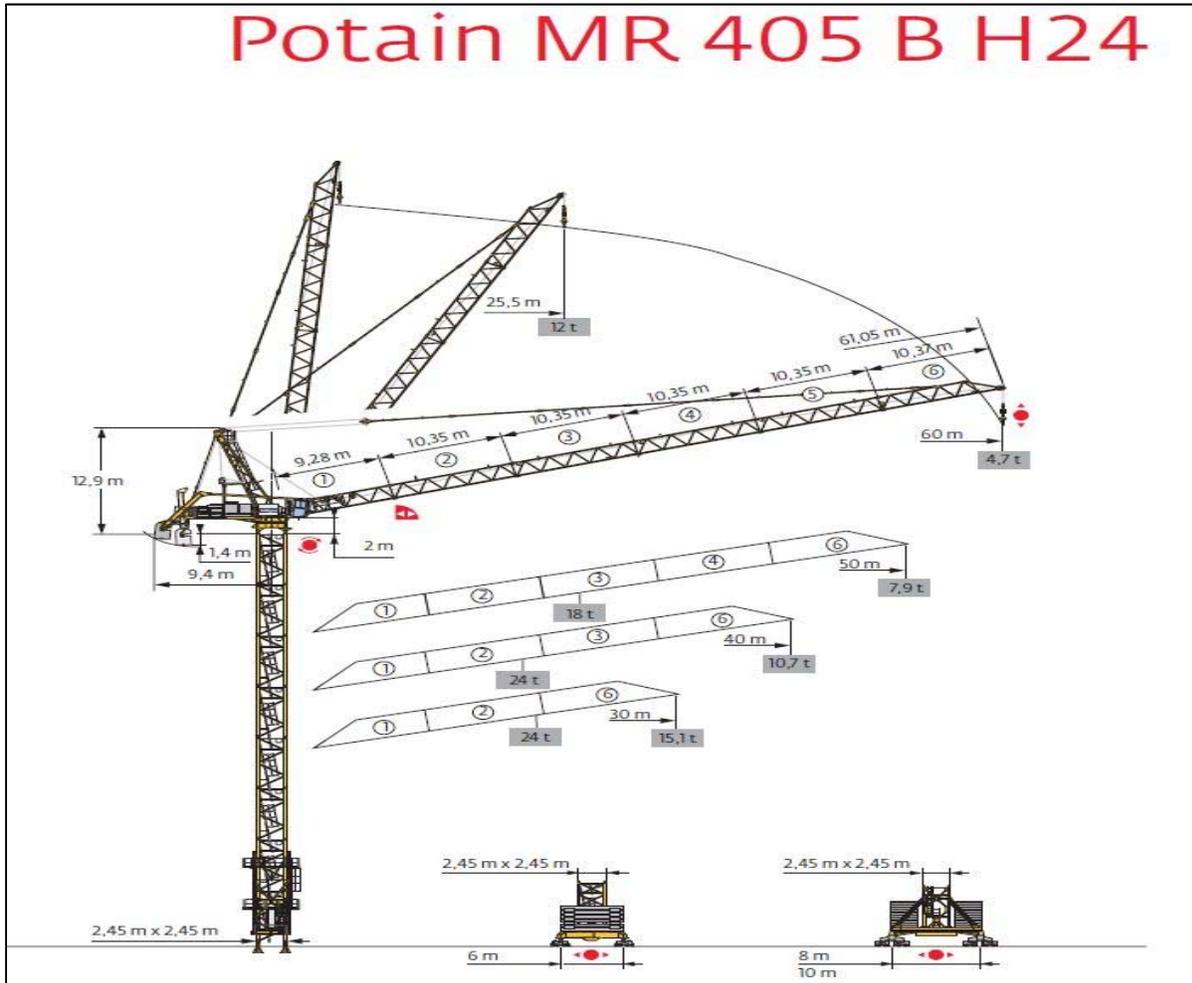
The tower crane hoisting system consisted of modular components that were bolted together. They were supported by 11 sections of mast, each 5 metres (m) in length, that when bolted together vertically were a total of 55 m in height. The mast structure was bolted to an engineered concrete pedestal base at ground level (Figure 2).

Figure 2. Rapicon Potain tower crane schematic drawing showing the main components of the tower crane hoisting system. (Schematic taken from the Manitowoc Potain MR 405 B H24 technical data brochure as provided to OHS by Rapicon)

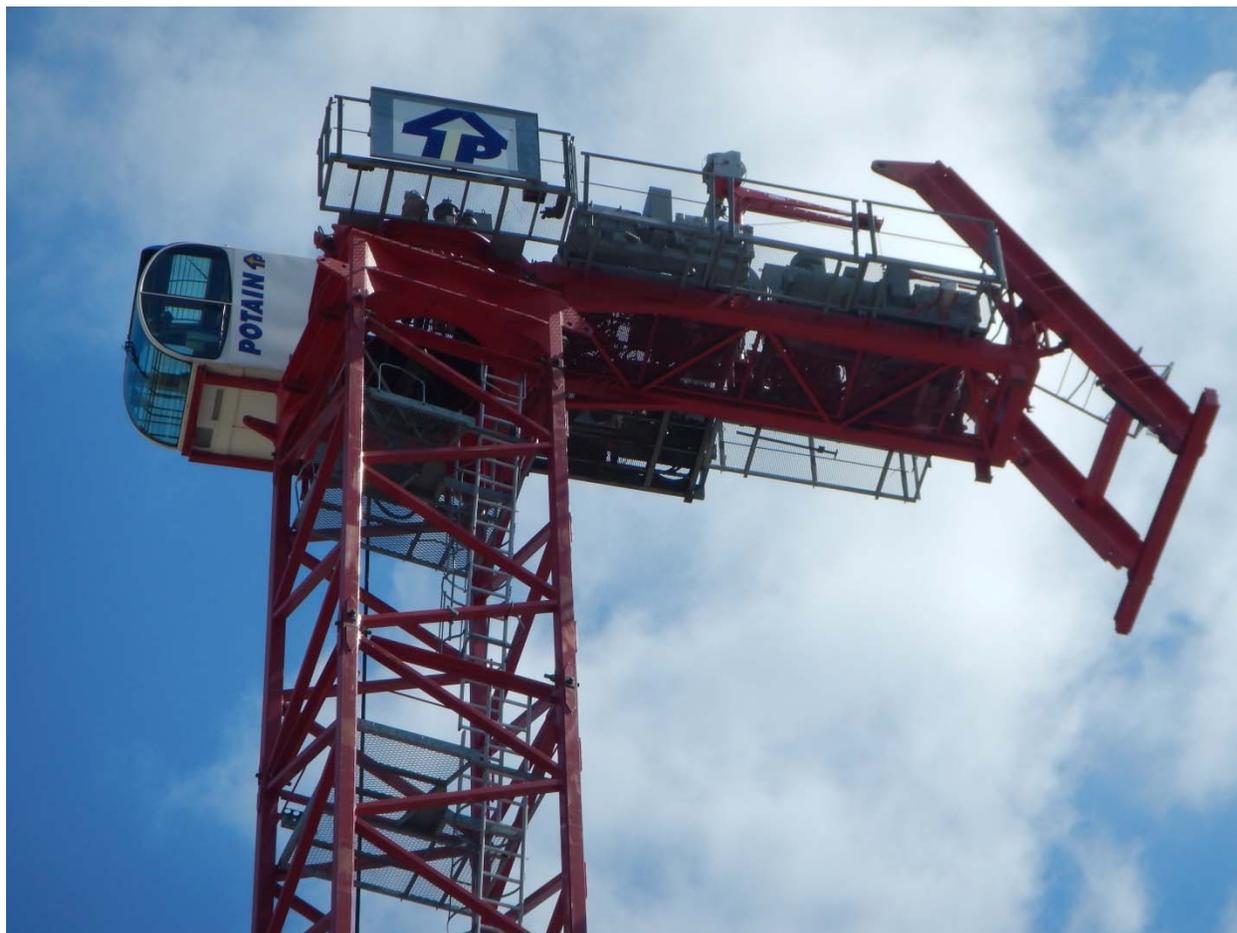
The tower crane was designed to lift varying weights ranging from a maximum of 24 050 kilograms (kg) when lifting a load close to the mast end of the jib, to as little as 4710 kg when lifting a load at the outer tip end of the 60 m long jib (Figure 3).

Figure 3. Side view of the Rapicon Potain tower crane with the jib and apex removed. (Royal Canadian Mounted Police (RCMP))

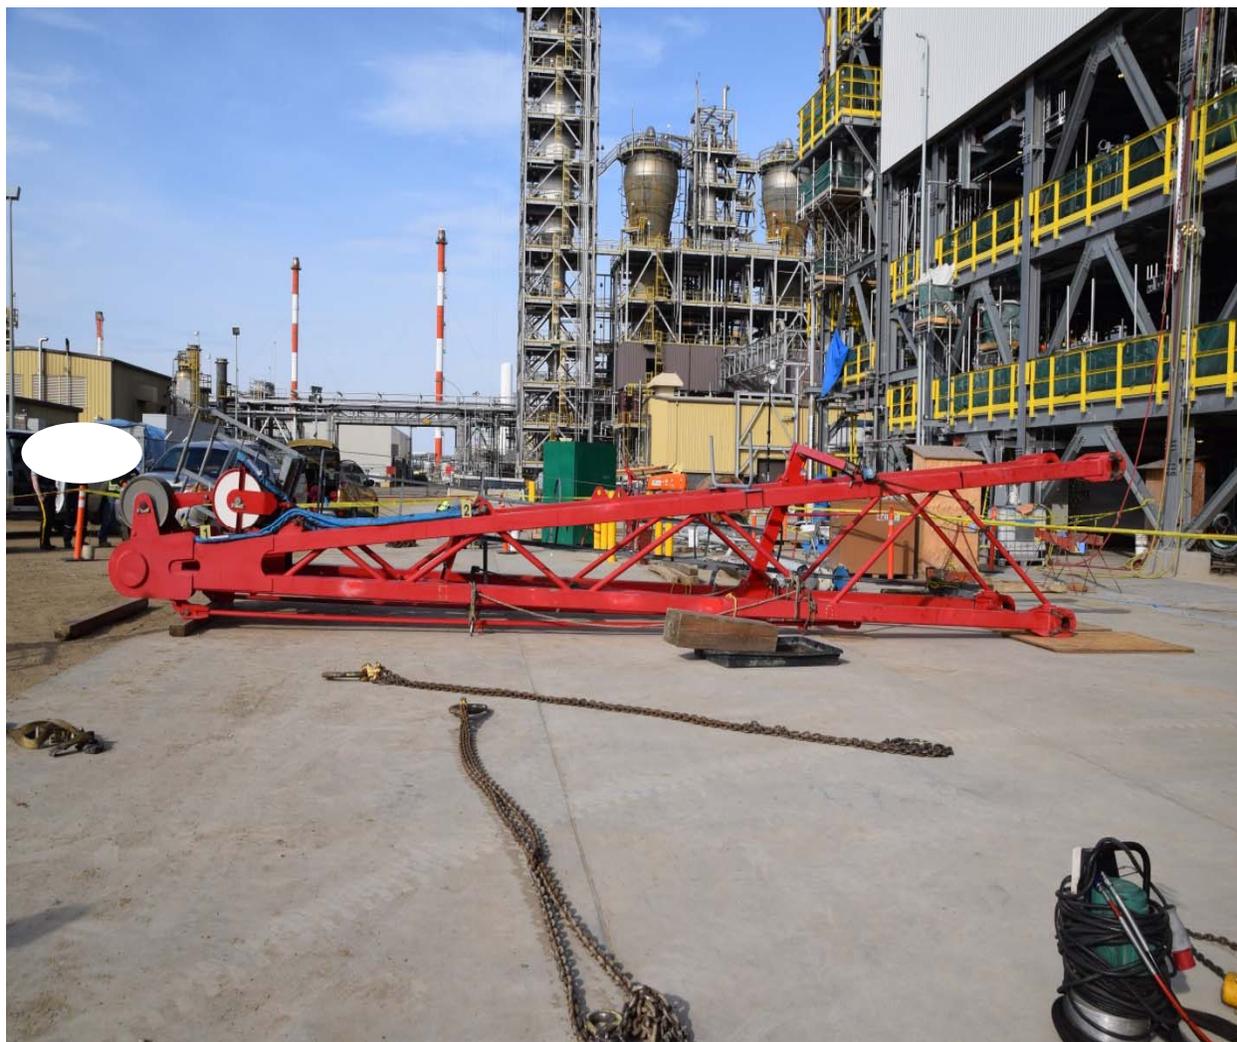
The purpose of the apex was to support the horizontal main jib over which the tower crane load hoisting lines ran. The apex was approximately 11.9 m long and weighed 5.65 tonnes (12 456 pounds) (Figure 4).

Figure 4. Rapicon Potain tower crane apex structure that was being hoisted by the Mammoet mobile crane when the accident occurred.

The apex was connected diagonally to the horizontal turntable by means of four 12.0 centimetre (cm) diameter steel locking pins. The pins were inserted through the apex lower leg mounting clevises (boots) and through mounting lugs (feet) on the turntable component.

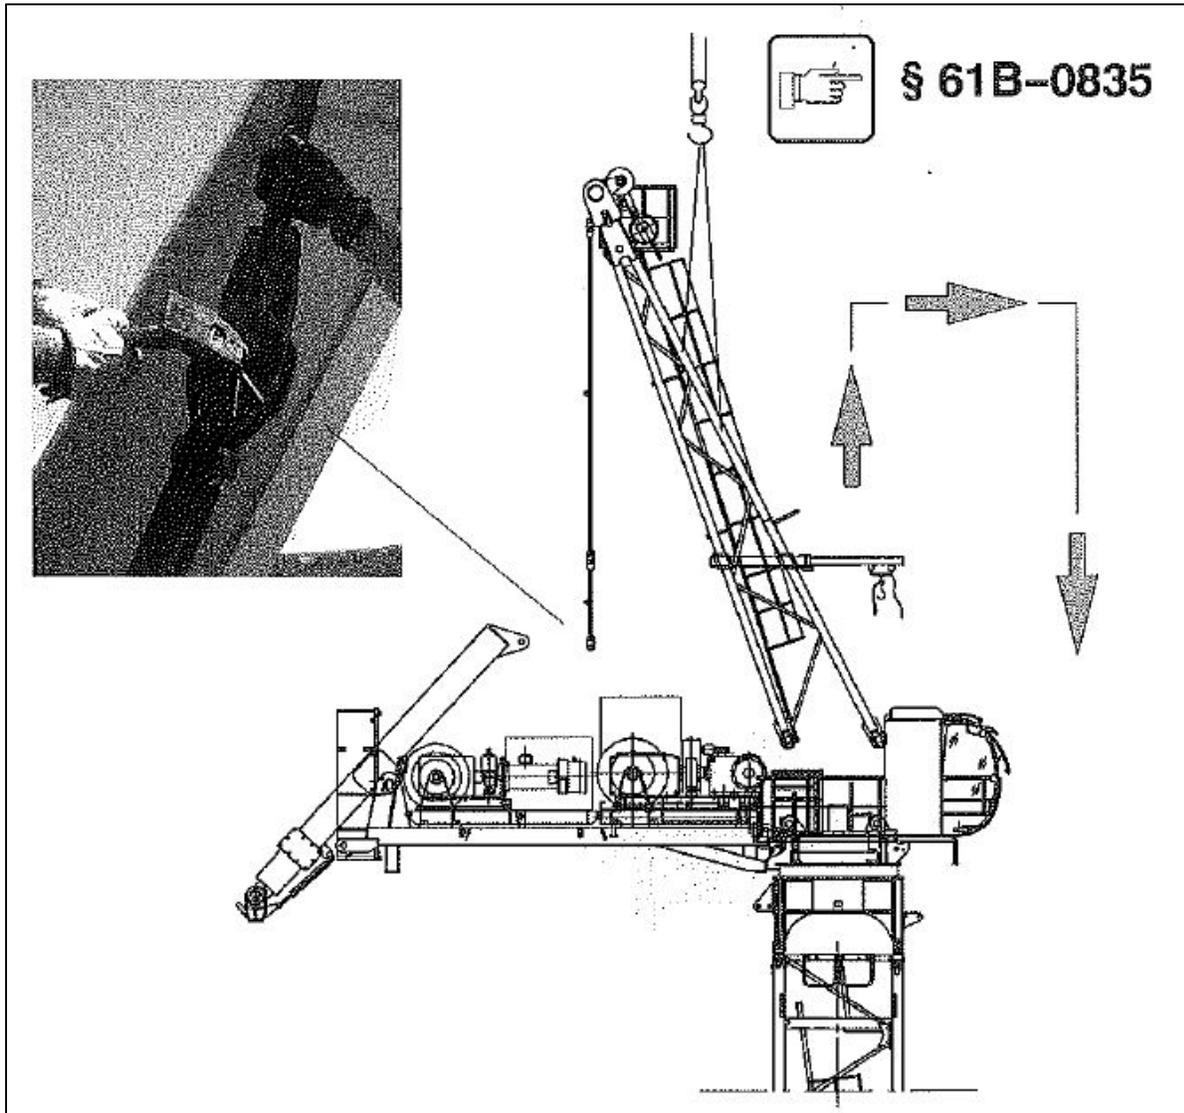
Removing the apex from the tower crane required the apex to be supported by a mobile crane in order to remove the four locking pins and lift the apex free of the tower crane turntable mounting lugs (Figure 5).

Figure 5. Schematic drawing of the Potain tower crane apex being hoisted by a mobile crane after the four locking pins had been removed from the turntable mounting lugs. (Taken from Potain tower crane specifications manual)

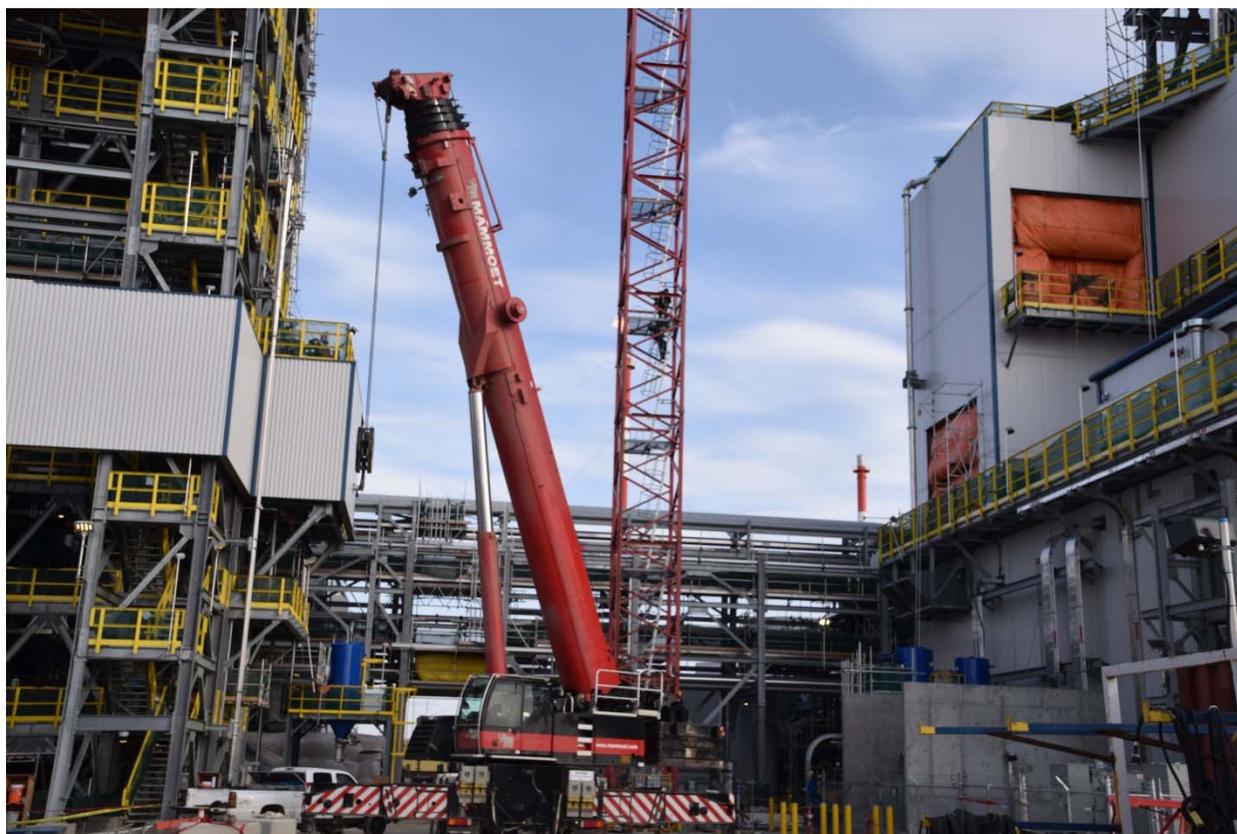
The mobile crane was equipped with a telescopic hydraulic boom that could extend to a maximum length of 72.0 m (236.2 feet). The mobile crane was equipped with an onboard computer system known as a load moment indicator (LMI) (Figure 6).

Figure 6. Mammoet Liebherr mobile crane with the telescopic boom fully retracted following the accident. The Rapicon Potain tower crane is shown in the background.

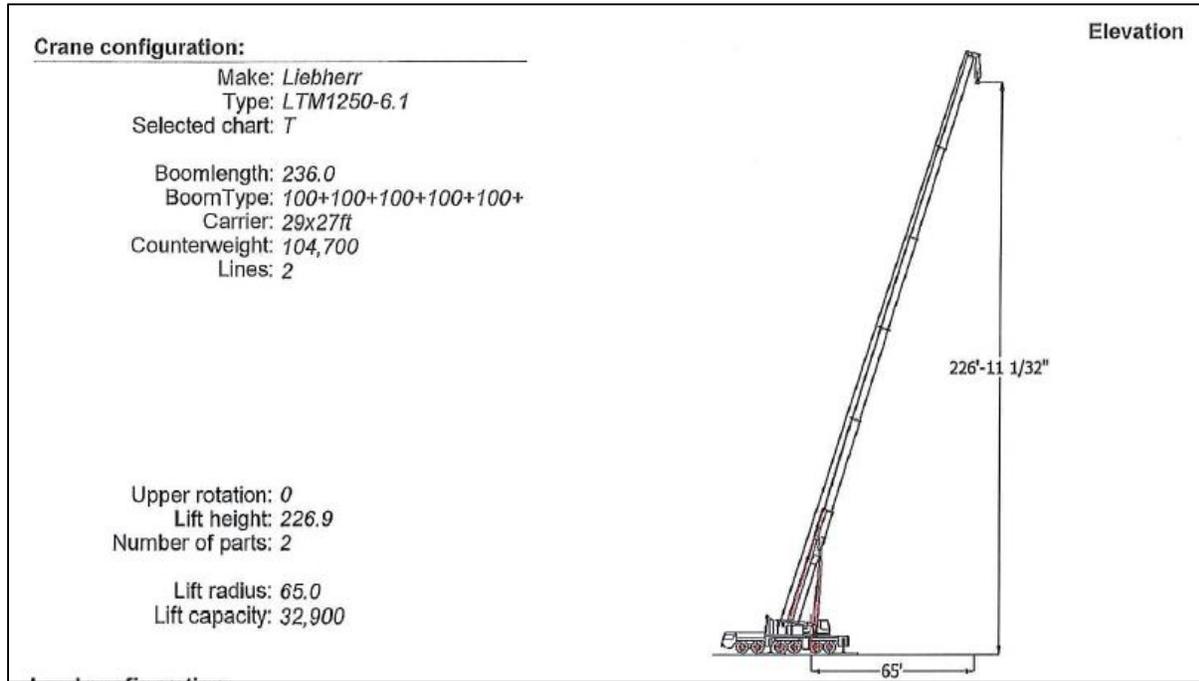
At the time of the April 27, 2016 accident, the mobile crane was being operated at a radius of 19.8 m (65 feet), with the boom fully extended to 72 m (236.2 feet), and a boom angle of 75.2°. The corresponding height of the mobile crane hoisting hook, as connected to the apex while hoisting the apex, was approximately 62.9 m (226.9 feet) (Figure 7, 8).

Figure 7. Mammoet mobile crane configuration crane for dismantling the Rapicon Potain tower crane. (Taken from the Mammoet lift plan for dismantling the tower crane)

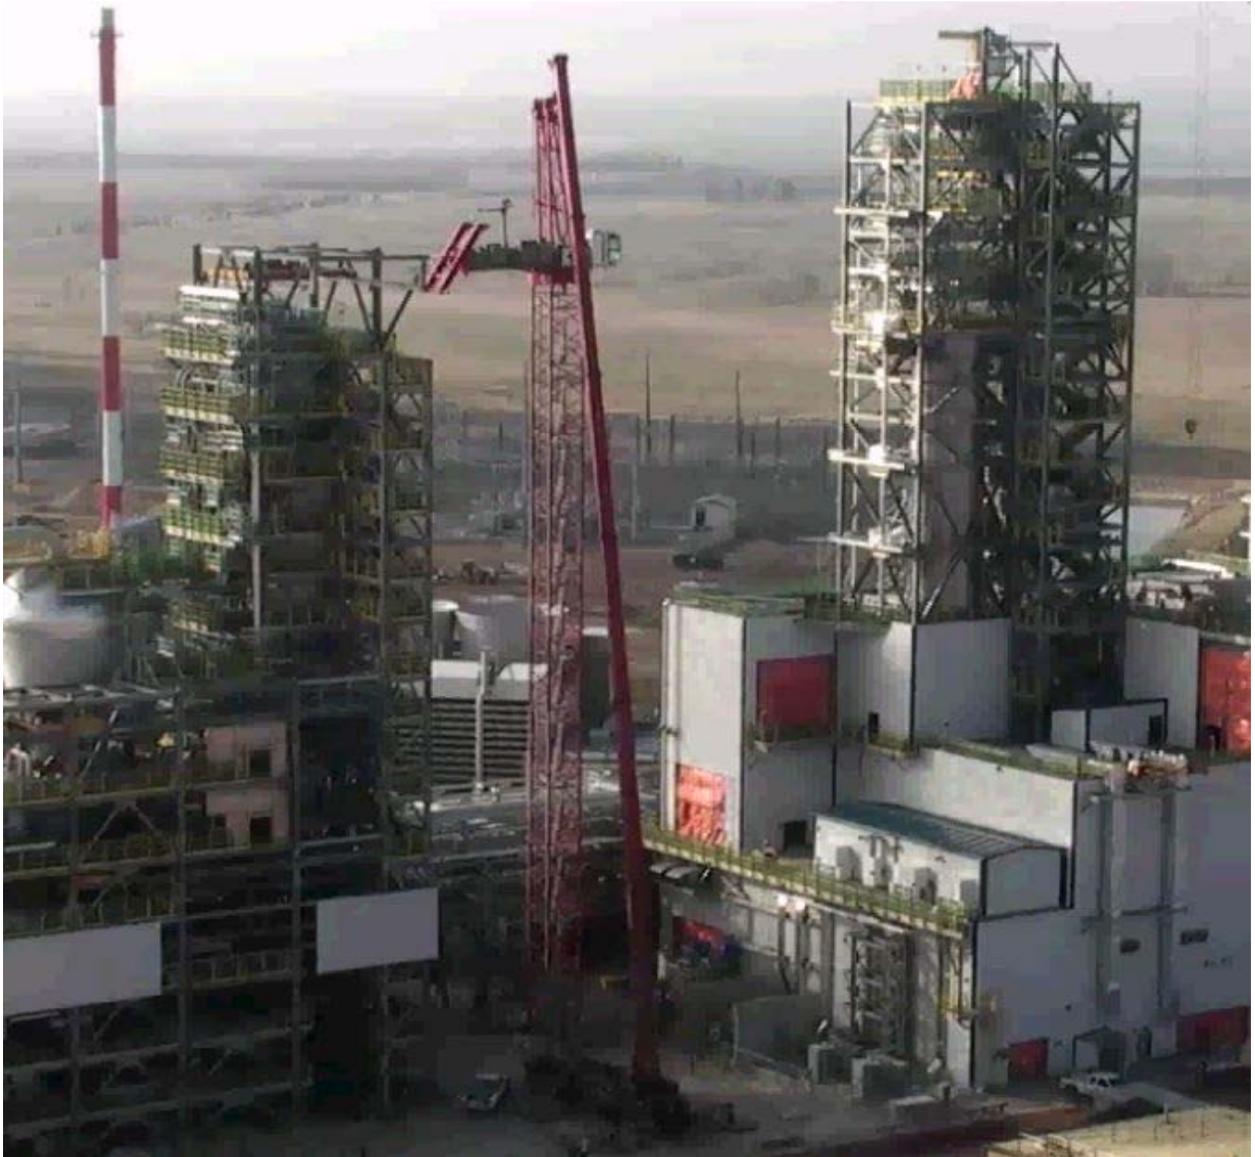
Figure 8. Side view of the Mammoet mobile crane connected to and attempting to hoist the Potain tower crane apex structure. (Taken from NOVA close circuit video system).

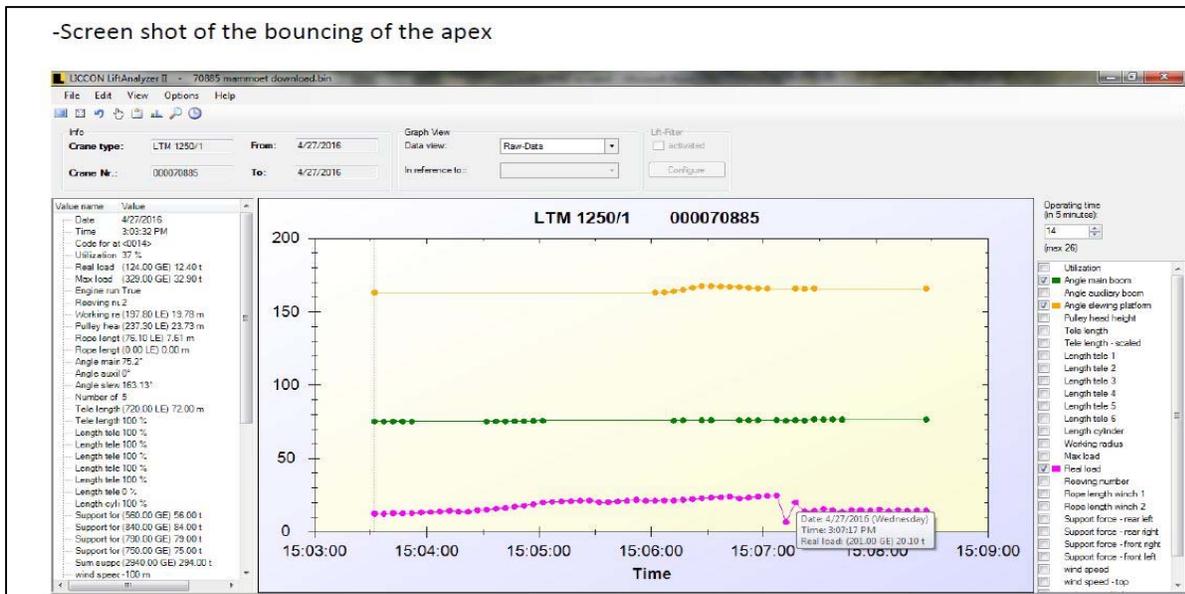
The mobile crane operator began increasing the lifting load on the apex in increments of five hundred pounds. The Summit Crane lead hand and Rapicon workers noticed that the front left front leg of the apex was still stuck to its mounting lug on the turntable despite the lifting load being applied by the mobile crane being well in excess of the weight of the apex.

At approximately 8:54 a.m., the Rapicon owner recognized there was a problem with the hoisting of the apex and used their radio to confirm what lifting load was being applied by the mobile crane on the apex. The mobile crane operator replied by radio that the mobile crane load moment indicator (LMI) was showing a lifting load of 8.6 tonnes (19 000 pounds).

At approximately 8:56 a.m., while under a lifting load well in excess of the weight of the apex, the apex suddenly released from the front left mounting lug on the turntable. The apex lunged vertically upwards approximately 2 m under the excessive lifting load being applied by the mobile crane (Figure 9).

Figure 9. Mammoet mobile crane data download showing the gradual increasing lifting load on the apex (purple dotted line) by the mobile crane from approximately 12 500 pounds to 24 000 pounds over a period of approximately 3.5 minutes and the sudden release of the apex from its turntable mounts at a lifting load of approximately 10.9 tonnes (24 000 pounds).

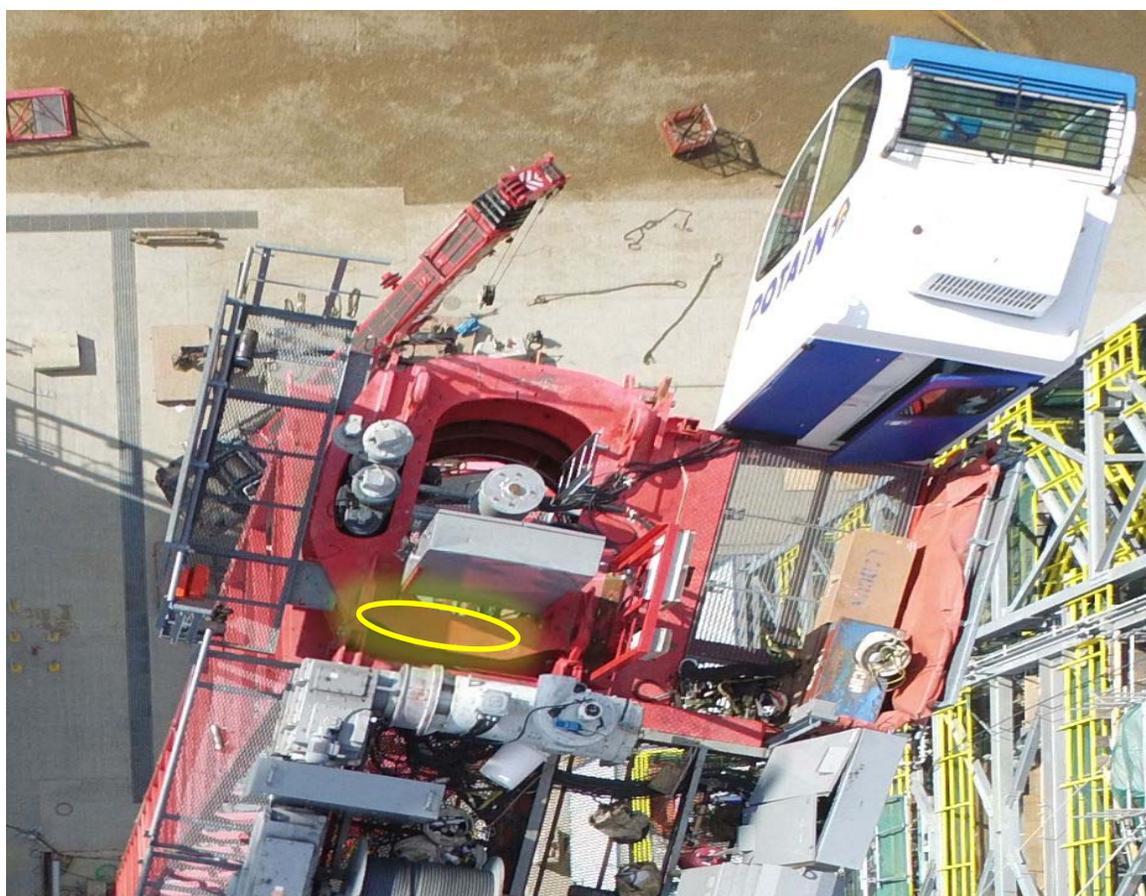
As the apex swung horizontally towards the back end of the upper platform, it struck worker 1 who was standing between the rear edge of the turntable and the adjacent hoist winch motor. Worker 1 was struck in the chest and crushed between the swinging apex and the hoist winch motor.

The apex then swung away from worker 1, and then swung back towards them, striking them a second time in the chest. The apex continued swinging back and forth several times before finally coming to rest up against the door of the tower crane cab (Figure 10).

Figure 10. The yellow oval shows the position where worker 1 was standing between the rear of the turntable and the adjacent hoist motor winch when struck by the swinging apex.
